# The Coincidence of Aging and the High Disaster Risk in Kochi Prefecture

A study comparing the demographic circumstances and lethality previous disasters with the current demographic situation in Kochi Prefecture, Shikoku Island, Japan.

University of Vienna

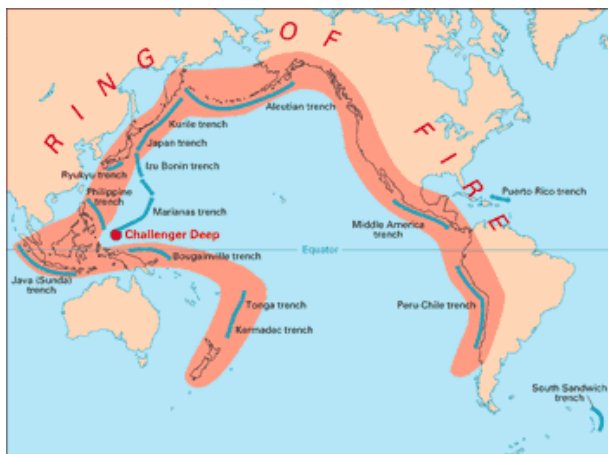
Figure 1 - The Ring of Fire (USGS, 2019)

Japan is known for its many earthquakes and tsunamis. This is due to Japans geographical position, which is located on the Ring of Fire, the most seismic region in the World. About 90% of the world's earthquakes occur there (USGS, 2019), many deep submarine trenches, even the deepest one, the Challenger Deep in the Mariana Trench and most of the active Volcanos are located along the Ring of Fire, which are the result of the movement and collusion of many lithospheric plates.

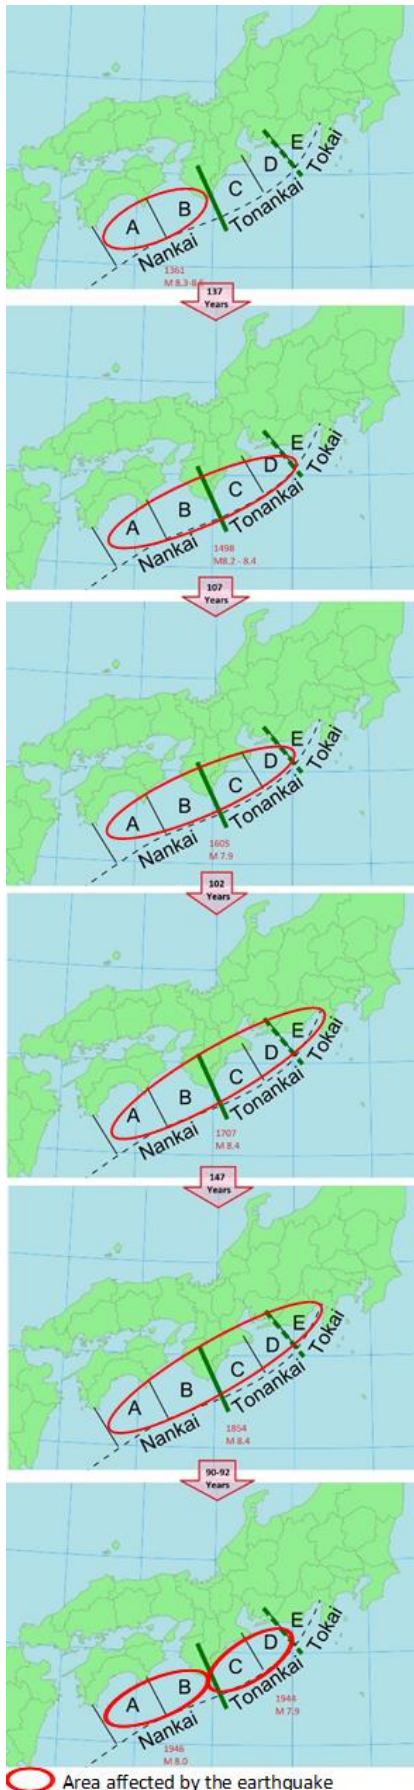
Figure 2 shows the recent earthquakes at the Nankai Trough, the year they occurred, their magnitude and the affected segments. It illustrates the interval between the earthquakes which is between 90 and 137 years.

Figure 2 - Recent earthquakes at the Nankai Trough

It is sure that in the near future a massive earthquake in the Nankai Trough will cause a big Tsunami. The size of the Tsunami will depend on the magnitude of the earthquake and other factors. Scientists are trying the best to calculate the maximum and expected size and impact of the tsunami, but history shows (2011 Tōhoku Earthquake) that they could possibly also underestimate the power of the wave. The most recent tsunami hazard maps for Kochi Prefecture are drawn based on a calculation of a magnitude 9.1 earthquake occurring in the Nankai Trough. An earthquake of this power is very unlikely to happen, the recent earthquakes in the last 700 years never exceeded the magnitude of 8.4 (Figure 2).

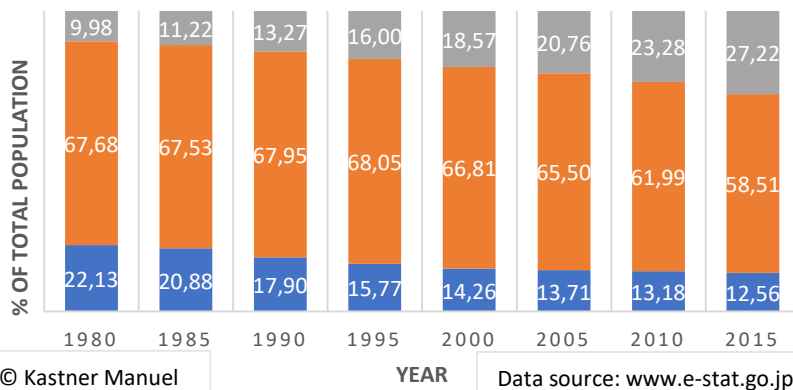
Figure 8 - Demography in Kochi city 1980-2015

Compared with the demographic development of Japan, the one of Kochi city is quite the same, just a slightly higher proportion of older people living in the city.

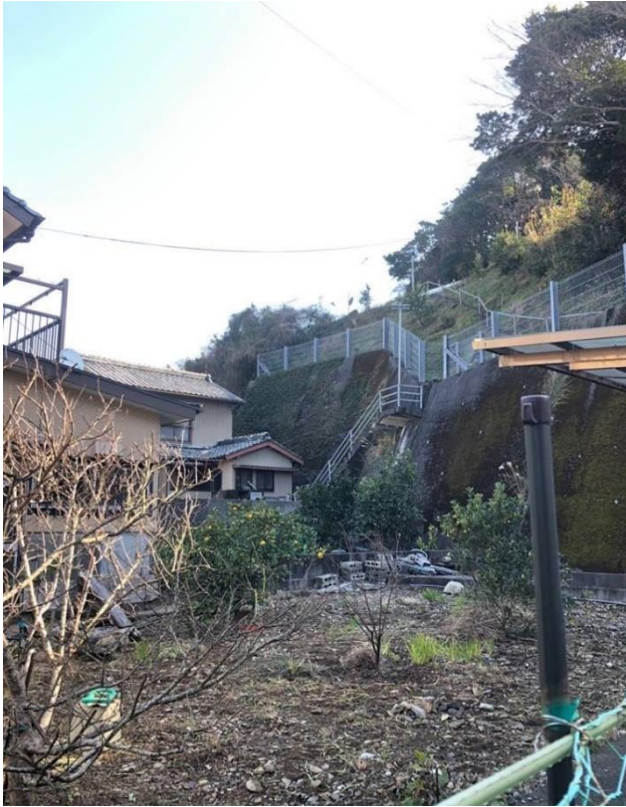
Picture 1 - Stairs, a part of the evacuation route (32°45'34.4"N 132°57'54.7"E)

Building tsunami protection could get expensive if you built a big tsunami wall or many evacuation towers but you can also use natural resources and the landscape as a protection, for example if you build evacuation routs on hillsides or plant a forest for tsunami protection. A local inspection in Tosashimizu showed that they are using both methods combined to reduce the potential tsunami damage. The geological situation in Tosashimizu city allows them to build many evacuation routes along the hillside to safer and high enough places. On the steep cliff like hillsides the locals build paved stairs while on the flatter hillsides the evacuation routes are sometimes not paved, only some stone plates lay on the ground to stabilize the ground. In some cases, the walkways are just natural trails in the grass or dirt. This could lead to big problems during an evacuation if the weather conditions are bad, if the ground is wet it could lead to slippery conditions causing people to fall. In this area, since there is a high proportion of elderly people, this could lead to people not reaching the evacuation points in time, especially during night time, when people need some time to realize what happens because they are still sleepy. On the positive side, many of the walkways had handrails to support the old and feeble citizens. (Picture 2 - Handrails and stoneplates to ensure the evacuation route

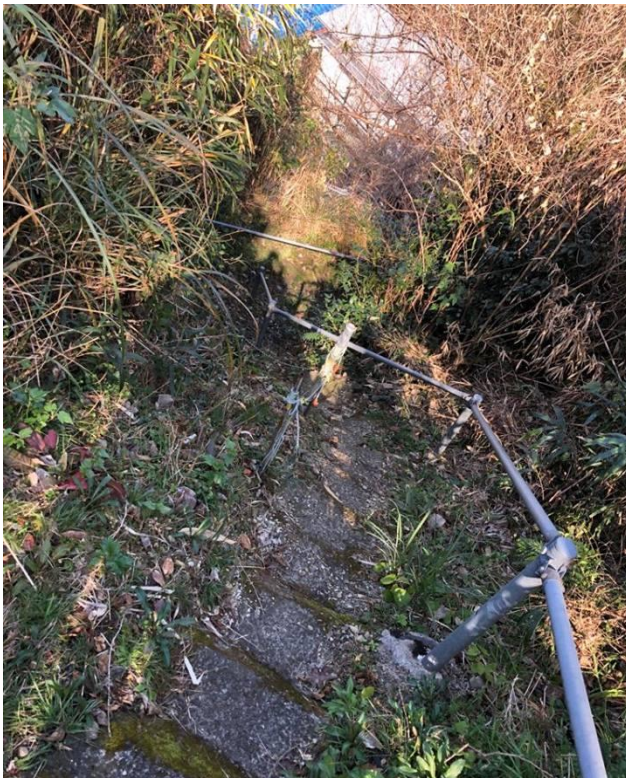
Picture 2 - Handrails and stoneplates to ensure the evacuation route (32°45'33.8"N 132°57'55.3"E)

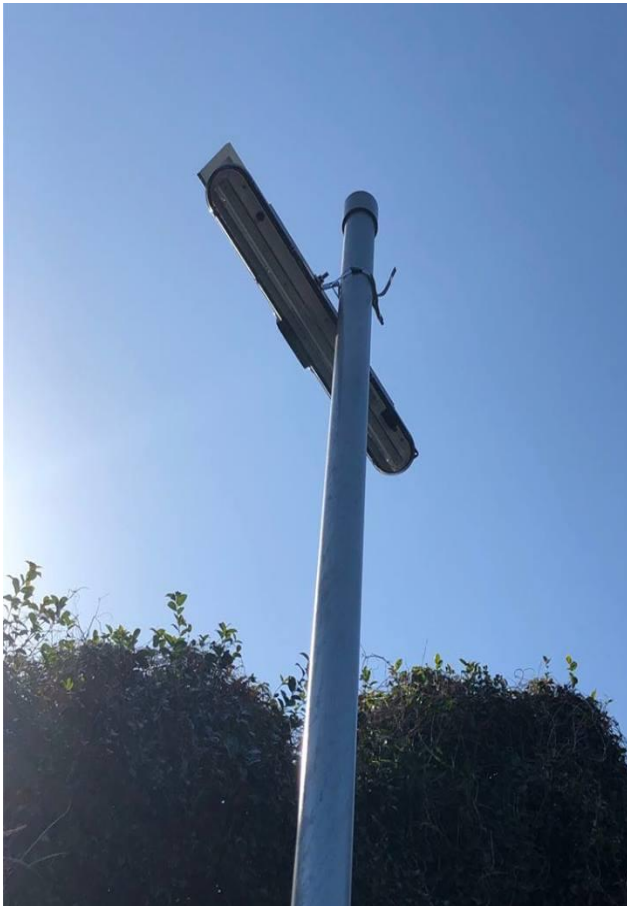
Picture 3 - A portable solar power light (32°45'31.8"N 132°57'56.2"E)

For the case that the earthquake happens during night-time, alongside the route are many portable, solar-powered lights. These lights can be taken out of their base and be carried by people who are fit enough. (Picture 3)

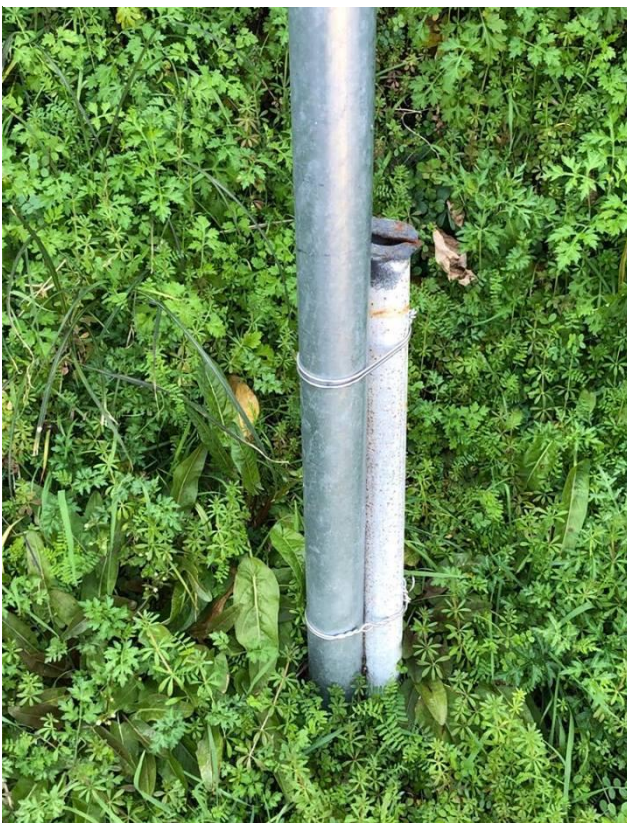
Picture 4 - Base of a portable light (32°45'31.8"N 132°57'56.2"E)

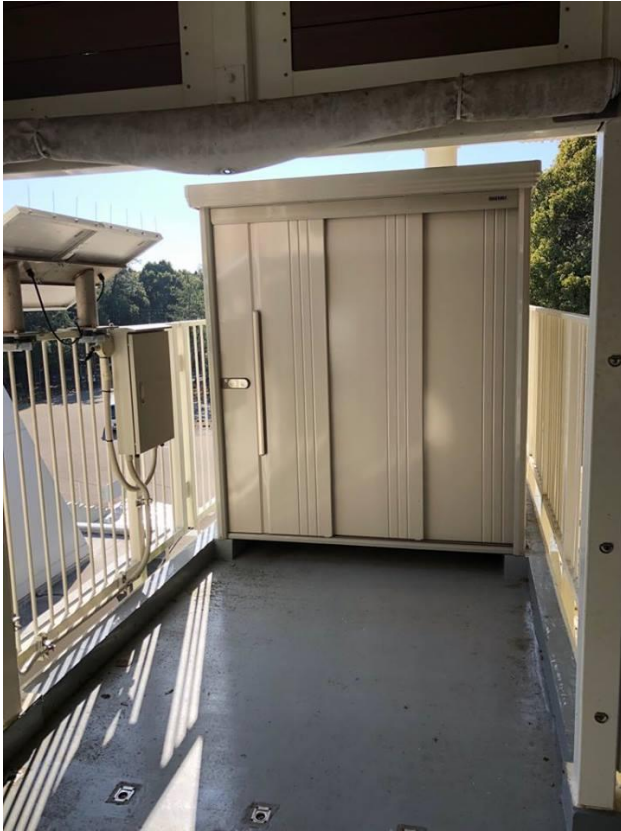
*Picture 6 - A supplybox on top of a tsunami evacuation tower (33°01'20.4"N 133°00'46.9"E)*

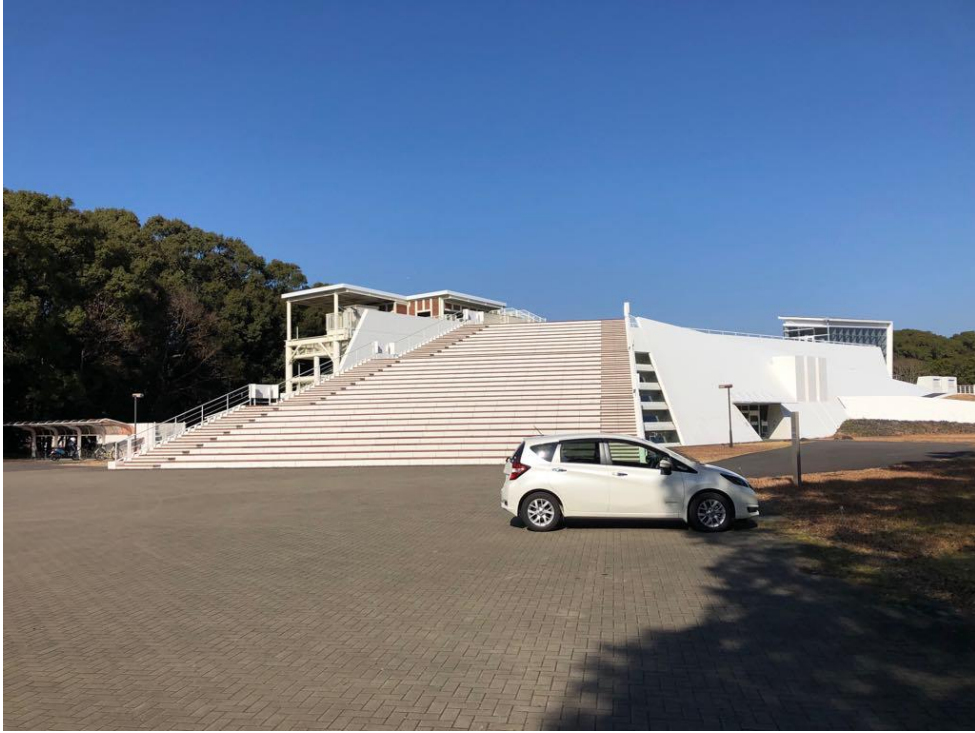
*Picture 9 - Tsunami evacuation tower and library in Shimanto (33°01'20.4"N 133°00'46.9"E)*

In another area in Kochi prefecture, in Shimanto, a tsunami tower had been built as a multifunctional building with a library underneath it. This is an effective way to lower the costs of the tower itself and makes it more attractive for investors.
